## Fire Risk Assessment

<b>Property Name:</b>	Canolfan Eirianfa Centre
<b>Client Name:</b>	Eirianfa Association
<b>Date of Assessment:</b>	4th February 2025
<b>Issue Date:</b> <b>Revision Date:</b>	11th February 2025 12th February 2025
<b>Unique Reference #:</b>	08363
<b>Name of Fire Risk Assessor:</b>	John Timperley MIFSM, MIFireE
<b>Validated By:</b>	Richard Franks MIFSM DipFD FSDip
<b>Powered by:</b>

### Regulatory Reform (Fire Safety) Order 2005 Fire Risk Assessment

A Fire Risk Assessment was carried out by Pyro Fire Services Limited at Factory Place, Denbigh, Denbighshire, LL16 3TS on the 4<sup>th</sup> of February 2025 on behalf of Eirianfa Association (hereafter referred to as The Client).

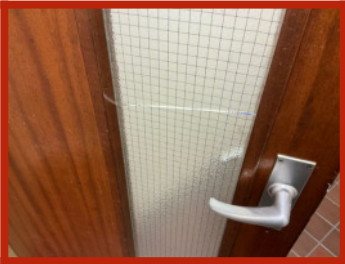
<p>● <b>#2431818: The Door Onto The Internal Staircase At Basement Level Has Broken Glass</b></p> <p>Description: It is recommended that the glass is replaced to ensure that smoke and other products of combustion do not pass the door.</p>

<p>Severity: Moderate</p>
--	-------------------------------

- #2431818: The Door Onto The Internal Staircase At Basement Level Has Broken Glass
- #2431821: Basement Door - Missing Self Closer
- #2431824: Room 1 Fire Door Is Not Closing Into The Rebate

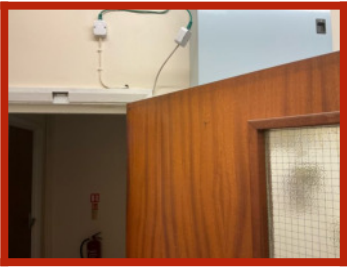
<p>● <b>#2431821: Basement Door - Missing Self Closer</b></p> <p>Description: The basement staircase door is missing a self closer.</p> <p>It is recommended that the door is installed with a self closing device to ensure the door is effectively self closing into the rebate from all angles.</p>

<p>Severity: Moderate</p>
<p>● <b>#2431824: Room 1 Fire Door Is Not Closing Into The Rebate</b></p> <p>Description: The centre suffered a collision by a vehicle which has knocked walls out of alignment.</p> <p>It is recommended that the door set is repaired or replaced to FD30s standard and that the door is self closing fully into the rebate from all angles.</p>

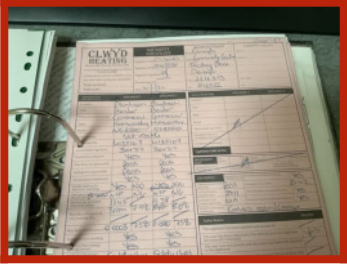
<p>Severity: Moderate</p>
<p>● <b>#2431815: Gas Safety Check</b></p> <p>Description: There is no documentary evidence available to suggest gas safety checks have been carried out for the premises in the last 12 months.</p> <p>It is recommended annual gas safety checks are carried out for the gas appliances and supply for the building with documentary evidence kept available for inspection.</p>

<p>Severity: Monitor / Review</p>

- Main boiler are located within the Plant Room with appropriate isolation points. Last dated test completed by Clwyd Heating January 2024 and is now overdue - see actions.
